GROWING CHALLENGES OF HEAT EXCHANGER'S OPERATION AND MAINTENANCE IN LNG PLANTS

M Zaparel Awang

Malaysia LNG Sdn Bhd, PO BOX 89, Tg Kidurong, 97007 Bintulu, Sarawak, Malaysia
mohdzaparel@petronas.com.my

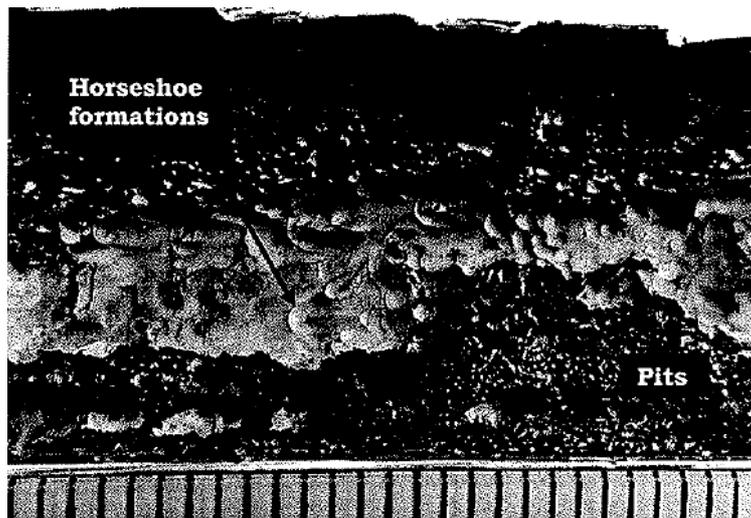
In early operation of heat exchangers in PETRONAS LNG Complex, there had been more than 150 documented cases of tubes failures occurred due to pin hole perforations initiated from the inside tubes (seawater). Since 1985, Eddy Current Testing (ECT) was used on selected heat exchanger to detect deteriorated tubes prior to perforations. Most of the tubes were found experiencing wall thinning which was greater than 35% weight loss.

Figure 2 Horseshoes Formation of Al-Brass Tube

All failed tubes of on aluminum brass tubes. Subsequently several heat exchangers which used the aluminum brass tubes were changed to Cupro Nickel tubes (70/30) to provide a better corrosion resistance for the sea water application. As Figure 2 indicates several 'horseshoe' formation was observed on the failed tubes which is an indication of metal removal due to the erosion.

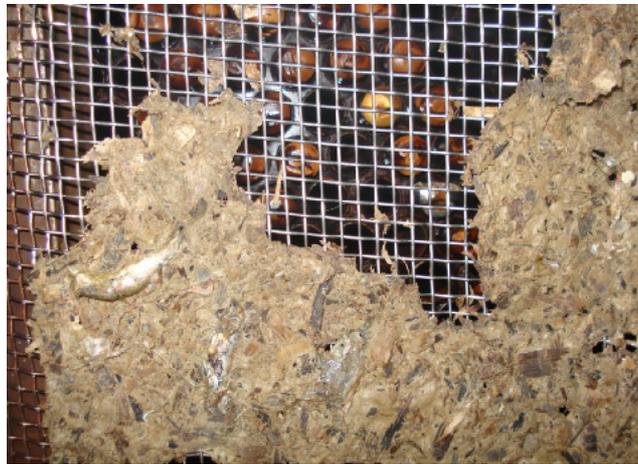
Figure 3 Blockage of Heat Exchanger Mesh Screen by Foreign Material

In 2007, it was also found that the blockage of the inlet of tube sheet (mesh screen which was installed in 1982) caused by out specification of saw dust injected to upstream of heat exchangers. The blockage of the tubes is subjected to low flow or no flow, thus corrosion initiated due to local concentrations of chlorides or the formation of calcium deposits.

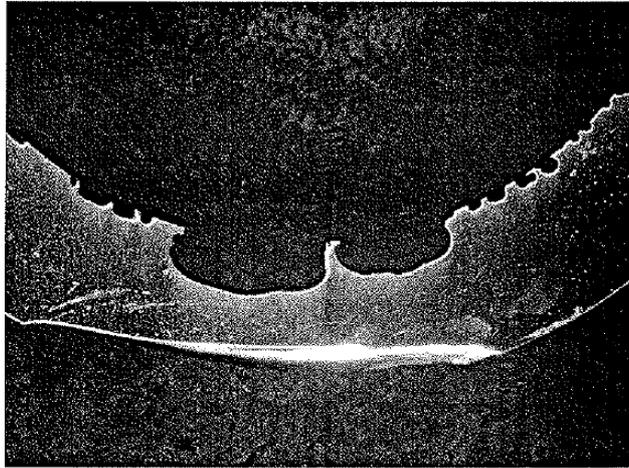
Figure 4 An Individual Small Pit Displays at Hemisphere Shape

Above figure reveals that small pits are hemispherical in shape and very likely start to merge with one another to form larger and deeper pits as the surface metal is further eroded.

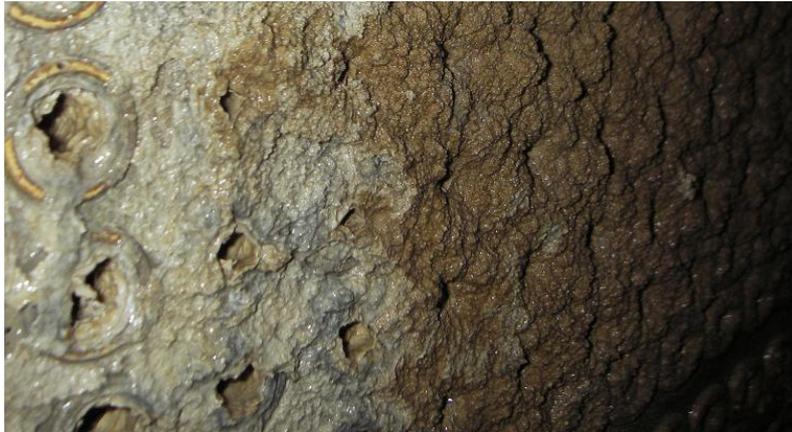
Figure 5 Tube Fouling due to Calcium Carbonate Growth

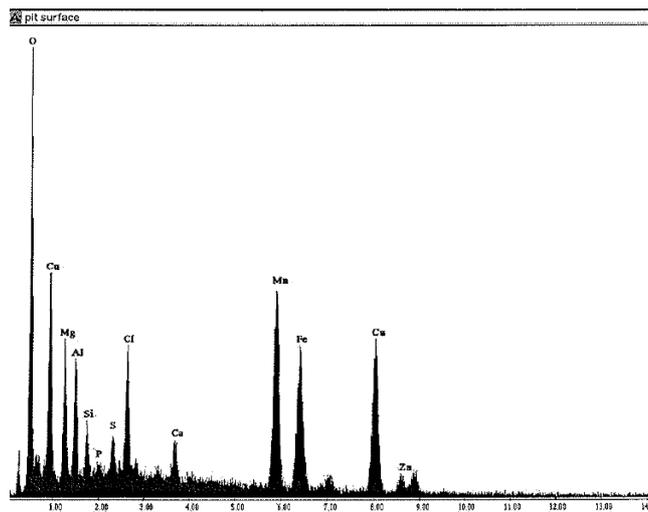
Based on Energy Dispersive Spectrometer (EDAX) Analysis, it was indicated that sulfur and chlorine were present at the pit surfaces which are not part of element that forms copper tube's protective layer. These elements, which are commonly found as sulphide and chloride ions such as environments, are known to cause severe corrosion in copper alloys. Furthermore, sulphide can also form a weak film which is easily removed through erosion.

Figure 6 EDAX Analysis on Pit Surfaces

Based on Figure 5, EDAX confirms that the presence of sulfur on the tube surface. This presence of sulfur leads to the formation of weak, porous, sulphine containing film as observed in Figure 6 instead of a stable oxide layer. The weak oxide layer can be easily damaged and become preferred pit surface for pits initiation. As damage become more severe, the effect of local turbulence and erosion become more significant.

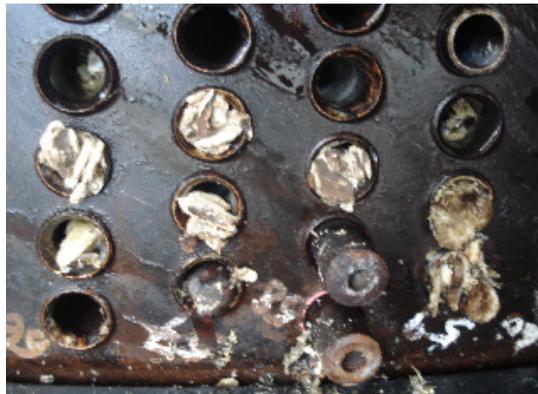
Responding to the high degree of tube blockage found the early days, the stainless steel screens were fitted in front of a number of inlet tube sheet commencing in 1985. This was to prevent debris from entering the tubes during operation.

The screen was fitted to above 25mm of the tubesheet as the tapered anchor plugs are not fully driven in. Debris caught on the screens are now 25 mm above the tubes ends. Consequently the tubes do not suffer from conditions of low or no flow as the debris do not directly cover all the tube ends.

Figure 7 Foreign Material Blocked Tubes

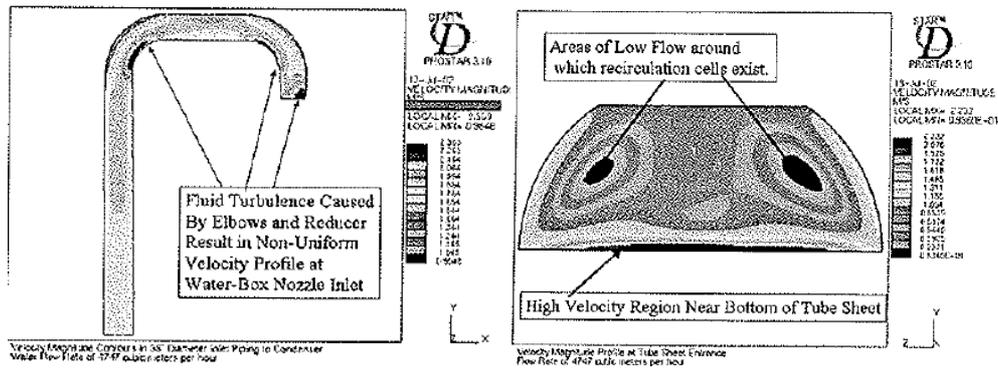
Besides all the corrective measures, a series of Computational Fluid Dynamic (CFD) calculations was conducted to determine possibility in improving the system by having a better understanding on the impact of the hydraulic leading to maldistribution inside the heat exchanger's channel boxes. The CFD studies of the flow through the inlet piping and water box into heat exchanger showed that there were fluid flow turbulence problem based on the current design at selected heat exchangers. The results further showed that the problem with the current piping design is that the fluid must flow through closely coupled elbows; through a reducer, through a sudden expansion, and then having to make a 90 degree turn in order to find its way to the tube sheets. Example of design issues are illustrated in the figures below.

Figure 9 CFD Results of Heat Exchanger Inlet Piping and Water Box

Based on these findings, it was decided to mitigate the problem by installing the bottom section of the tubes in the first pass with a better tube material instead of Al-Br which are more resistance to high velocity and erosion effects.
