BACTERIAL ADHERENCE ON A POLYMERIC COATING APPLIED ON CARBON STEEL

Sandro Nicolino¹, Monica Zapponi¹, Sonia Bruno¹, Verónica Rodríguez Bauzada¹, Pablo Castro¹, Marisa R. Viera^{2,3}, Silvia E. Rastelli^{2,4}, Sandra G. Gomez De Saravia^{2,4}, Cecilia I. Elsner^{2,5}, Alejandro R. Di Sarli², Mauro Banera^{2,5}

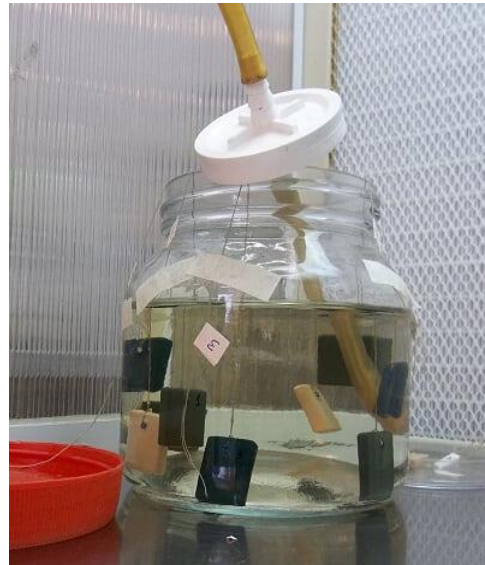
Flasks containing 1L of Postgate's C medium

Inoculum: a 3-day-old mixed culture of SRB (obtained from an oil storage tank)

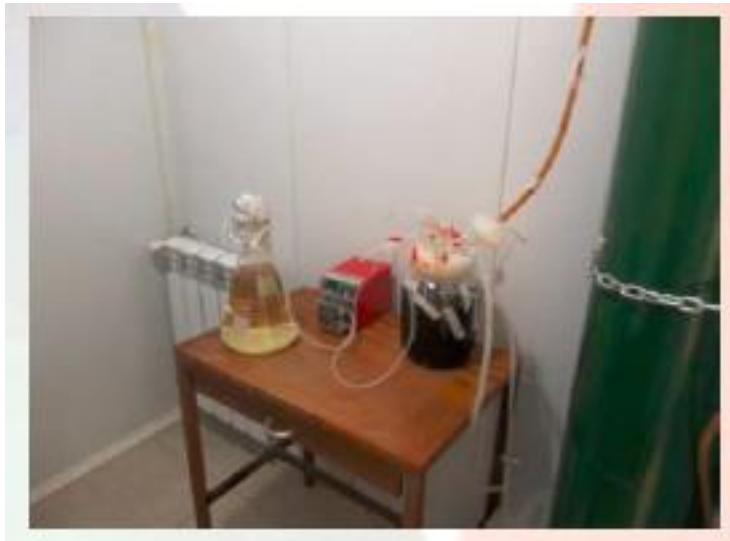
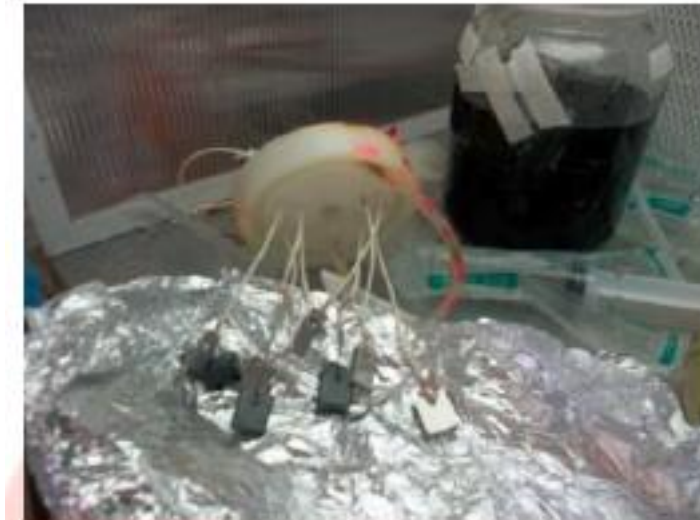
In order to evaluate the performance of the polymeric coating in long term exposure to a SRB environment, a continuous bioreactor is currently under operation. The SRB consortium is cultivated in a 2L bioreactor, where several coupons were placed. Postgate's C medium is continuously fed in the reactor. Sulfate concentration, pH and redox potential in the culture are monitored. The OCP of coated and uncoated steel is periodically measured.
